Manhole Inspection Summary

Manhole # S13U__005MH

Insp Date: **3/18/08 2:42 PM**

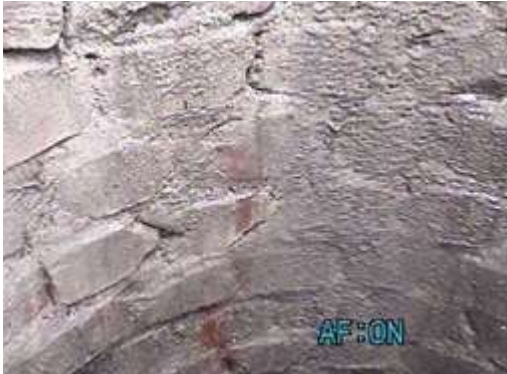
Defect 3

Infiltration: ☐ None ☒ **Joint** ☐ Cracks ☒ **Mortar** ☐ Roots ☒ **Wall**

corbel infiltration

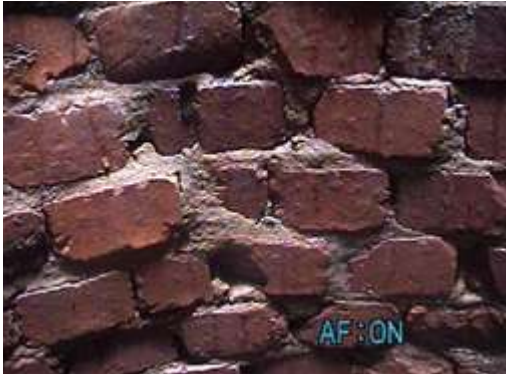
Defect 1

Infiltration: ☐ None ☐ Joint ☐ Cracks ☒ **Mortar** ☐ Roots ☒ **Wall**

barrel infiltration

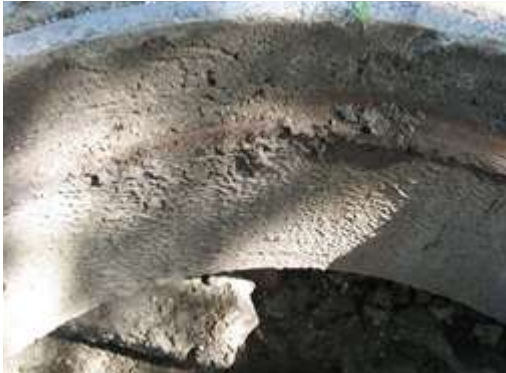
Defect 6

Frame Offset: **2.** (in.) Condition: ☐ Sound ☐ Cracked ☒ **Leaks**
25

lid-frame infiltration

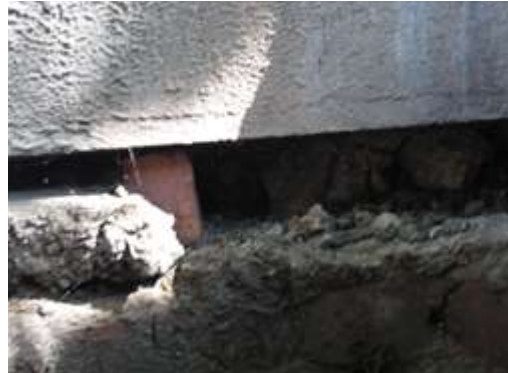
Defect 5

Condition: ☐ Sound ☐ Cracked ☐ Root Intrusion ☒ **Loose Brick** ☒ **Deteriorated**

missing mortar and brick

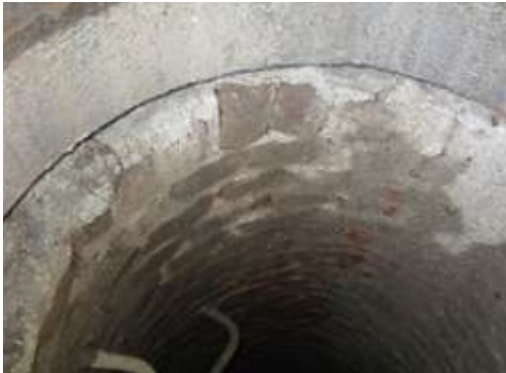
Defect 4

corbel infiltration

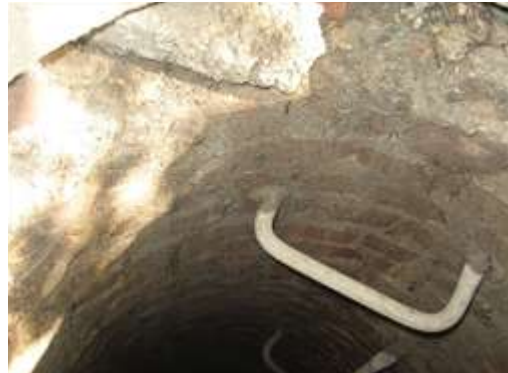
Defect 7

offset 2.25

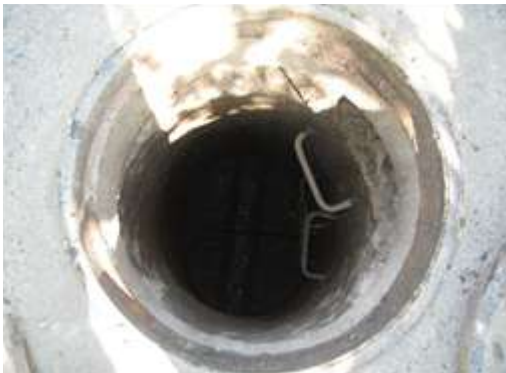
Defect 2

Steps Count: **5** Missing: **0** ☒ **Corroded**

Corroded Steps

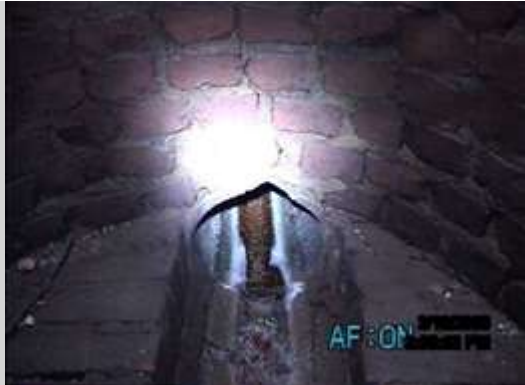
12 O'Clock Outflow

8 in. Circular Gravity Sewer
Pipe Out @ 12 O'Clock

Pipe Height: **7.2** (in.) Rod and Bar (Angled)
Pipe Material: **Clay** ☐ Pipe Lined
Invert Depth: **10.36** (ft.) Flow Characteristics: **Slow**
Deposits: ☒ None ☐ Mud ☐ Sludge ☐ Debris ☐ Grease
Silt Depth: **0** (in.) Deposits Extent:
Infiltration: **None** Pipe Seal Cond: **Sound**

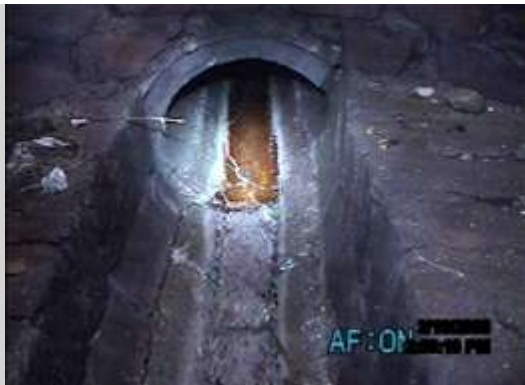
6 O'Clock Inflow

8 in. Circular Gravity Sewer
Pipe In @ 6 O'Clock

Pipe Height: **7.2** (in.) Rod and Bar (Angled)
Pipe Material: **Clay** ☐ Pipe Lined
Invert Depth: **10.70** (ft.) Flow Characteristics: **Slow**
Deposits: ☒ None ☐ Mud ☐ Sludge ☐ Debris ☐ Grease
Silt Depth: **0** (in.) Deposits Extent:
Infiltration: **None** Pipe Seal Cond: **Sound**
